Project: **Purley Leisure Centre**

Client: **Croydon Council**

Condition Survey of M&E Services

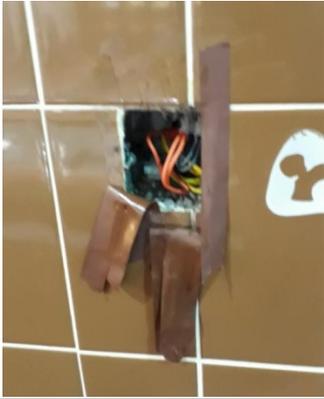
< Covers missing from socket sin Pool/Wet change side

1. Full Electrical Inspection and rectification works – there are various sockets and outlets in the building that are in need of attention.

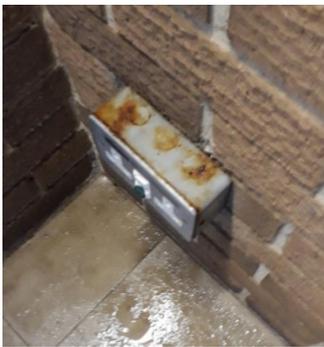
< Condense dropping on outlets not IP rated.

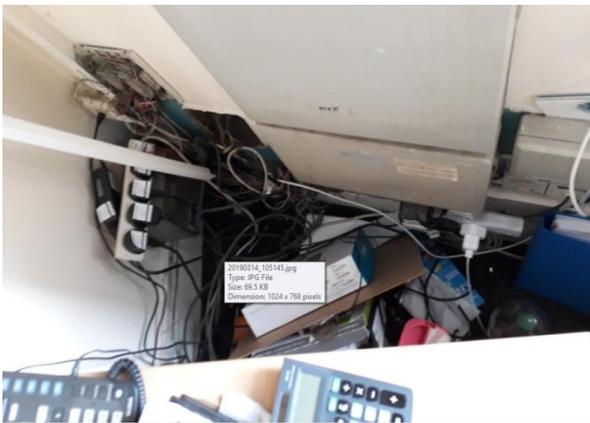
< Use of multiple extension leads

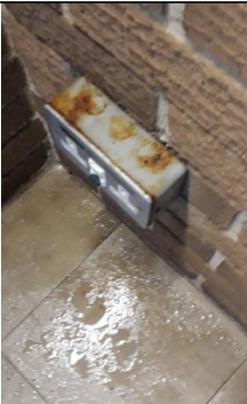
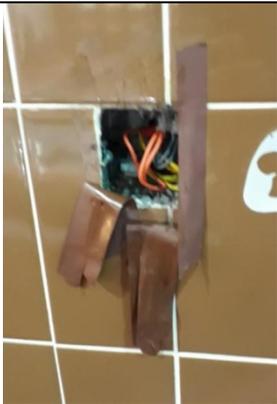
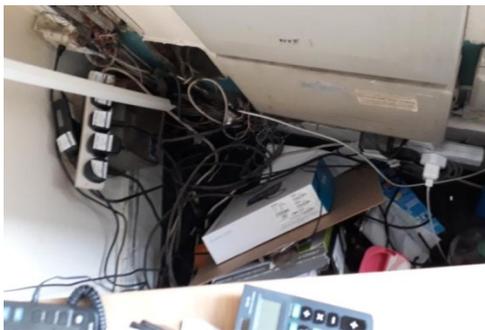
The whole building should be electrically tested and immediate works undertaken to ensure cover plates are secured and/or replaced as appropriate. There are instances throughout the building where covers plates are either not securely, fixed, not IP rate as required and not installed at all.

<p>Condense water dripping on to a non IP rated outlet</p>	<p>No cover plate to live circuits in wet area</p>	<p>Over loading circuits through use of extension cables.</p>
