## **Stock Condition Survey**

**Cradley Heath Community Centre  
Reddal Hill Road,  
Cradley Heath  
B64 5JG**

**Job No: 34456  
Date: 22 December 2022**

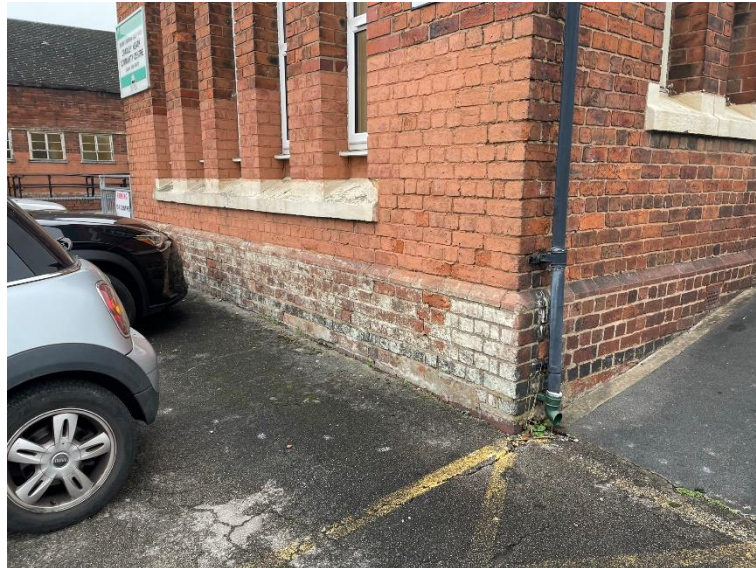
Photo 1 - Example of Repointing

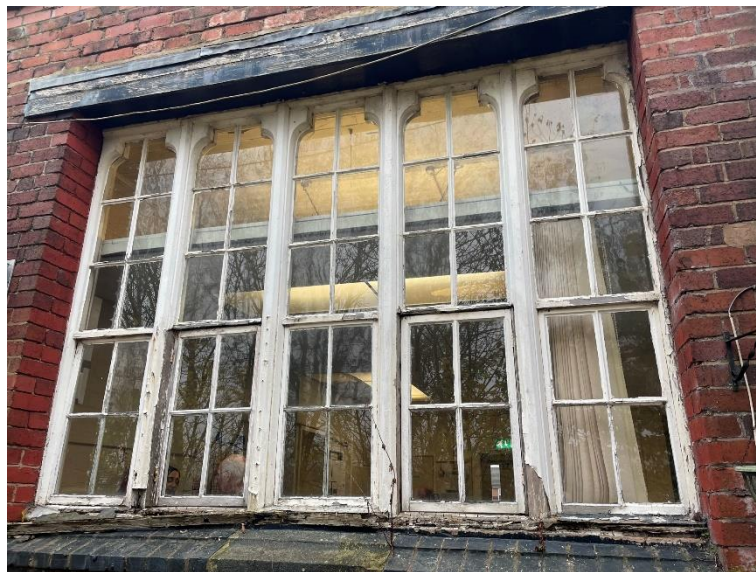
Photo 2 - Poor Condition Timber Window

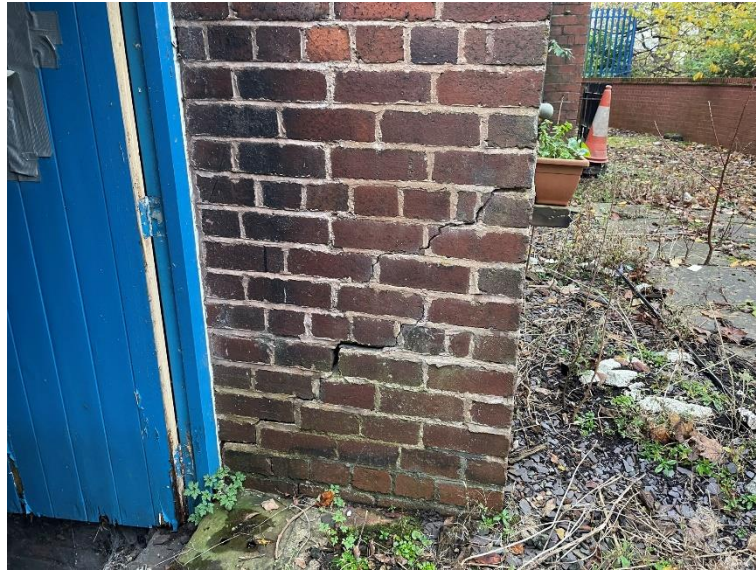
**Photo 3**

Rear		Elevation	Brick		C	Significant stepped crack to the corner of Room 2 externally. It would appear that underpinning of the corner of the building may be required, however, a structural engineer should assess the area.	Repair	Essential	Item	1	£ 1,150.00	£ 1,150.00		£ 1,150.00						
Generally		Windows	PVC-U		B		Monitor	Longer Term				£ - £ -								
Rear	Room 2	Windows	Hardwood - Timber		D	Severe degradation of the frames and glazing putty.	Replace	Urgent	Day	1	£ 4,500.00	£ 4,500.00	£ 6,075.00	£ 6,075.00						
Generally		Windows	Hardwood - Timber		C	Deterioration of the frames and glazing putty.	Replace	Essential	No.	32	£ 4,500.00	£ 144,000.00	£ 194,400.00		£ 64,800.00	£ 64,800.00	£ 64,800.00	£ 64,800.00		
Citizens Advise		Windows	PVC-U		B		No Action	Longer Term				£ - £ -								
Generally		External Doors	PVC-U		B		Monitor	Longer Term				£ - £ -								
Rear	Room 2	External Doors	Softwood - Timber		C	Completed rotted frame to rear building door into basement.	Replace	Essential	Item	2	£ 3,500.00	£ 7,000.00	£ 9,450.00

**Photo 3 - Stepped Cracking**

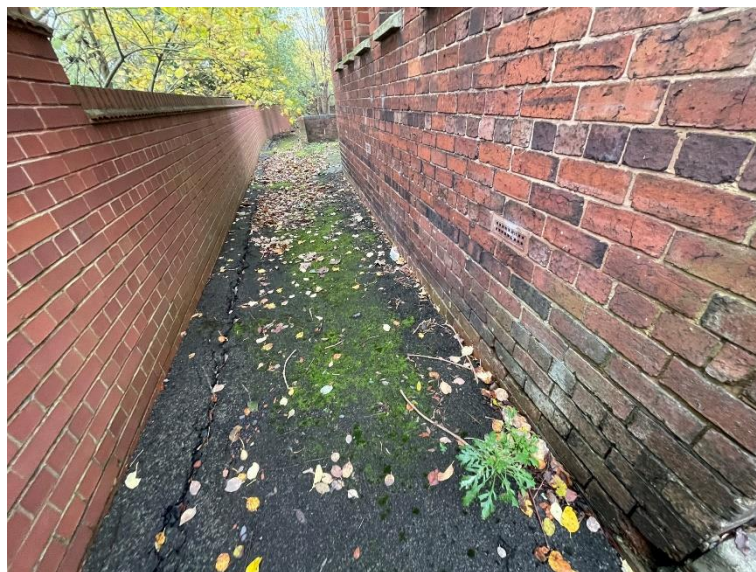
**Photo 4**

**Photo 4 - Cracking to Tarmac suggests Footing Issues to Wall**

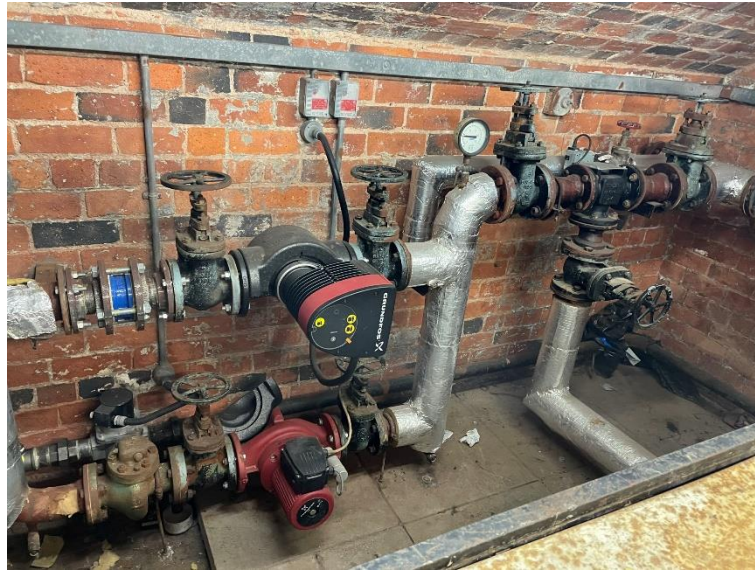
**Photo 5**

**Photo 5 - Dated Mechanical Equipment**

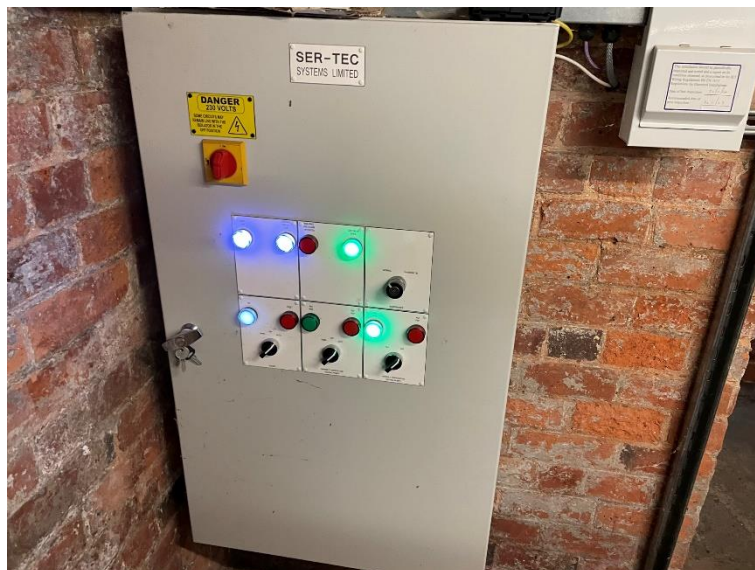
**Photo 6**

**Photo 6 - Dated Building Management**

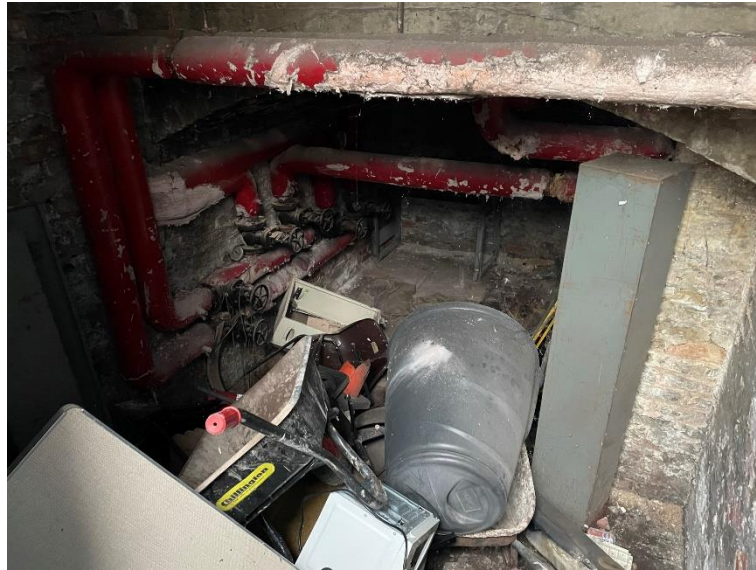
**Photo 7**

**Photo 7 - Existing Pipework**

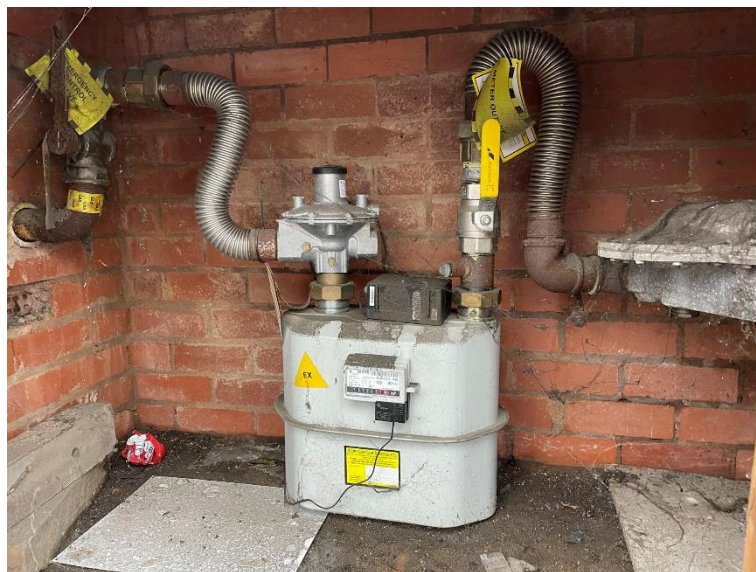
**Photo 8**

**Photo 8 - Gas Meter with Corroded Pipework**

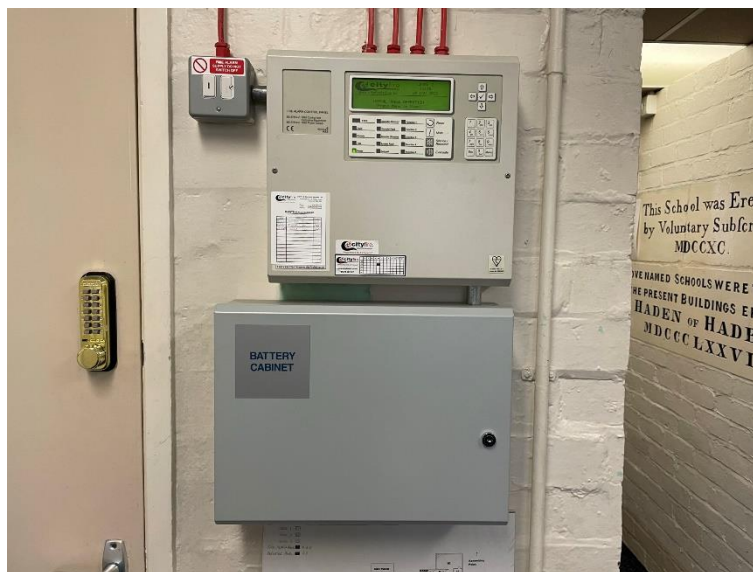
Photo 9 - Fire Alarm Board

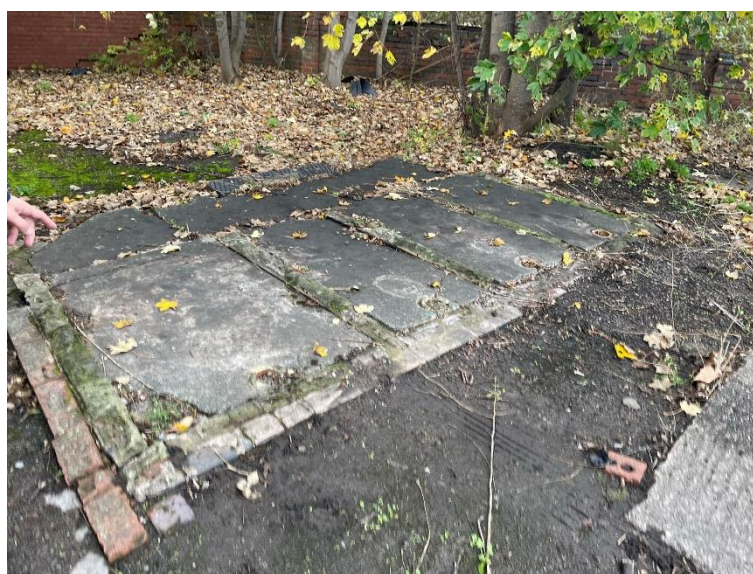
Photo 10 - Concreted Historic WCs

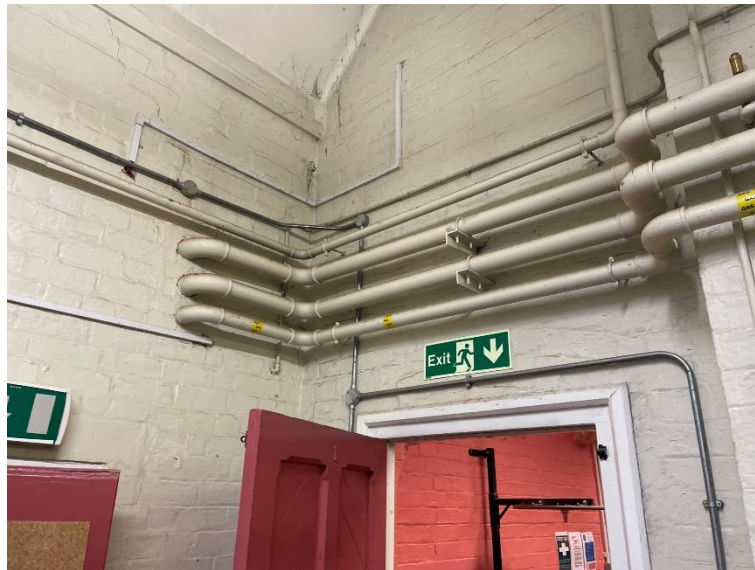
Photo 11

Photo 11- Uninsulated Pipework

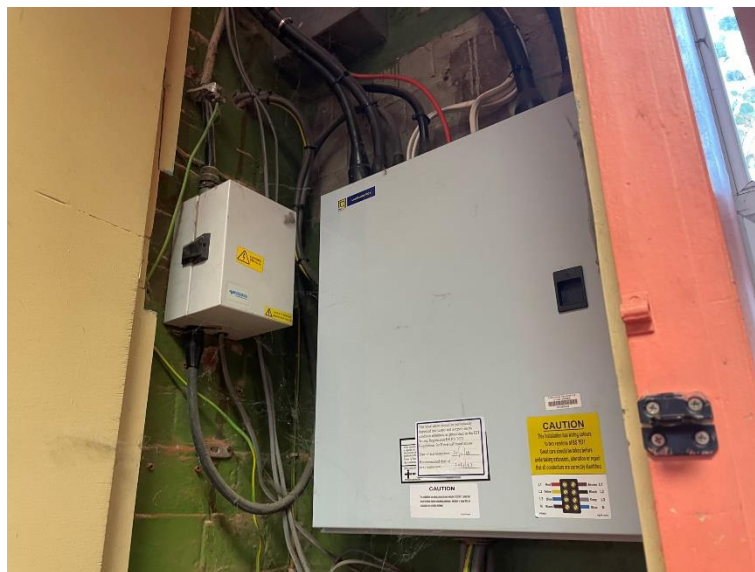
Photo 12 - Dated Electrical Installations

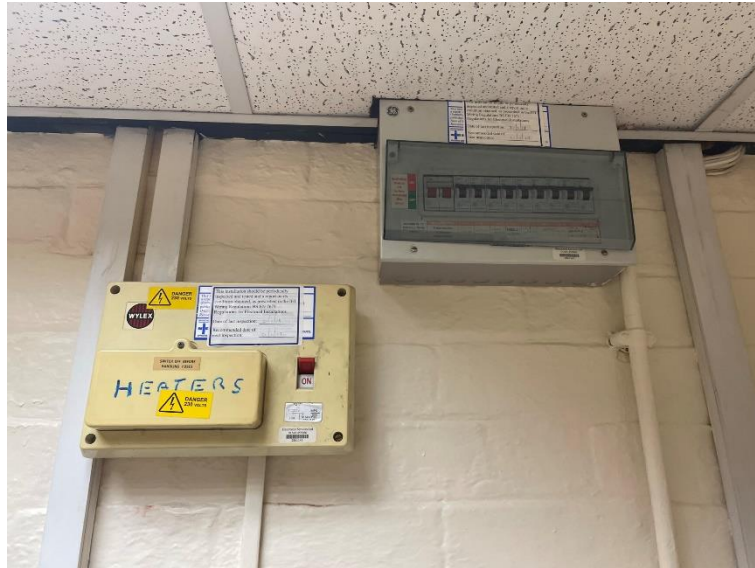
Photo 13 - Dated Electrical Installations

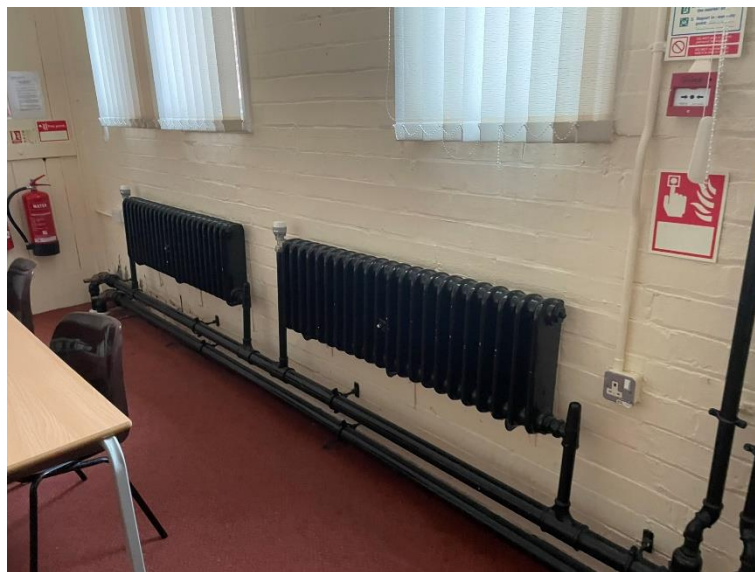
Photo 14 - Exposed Cast Iron Radiators

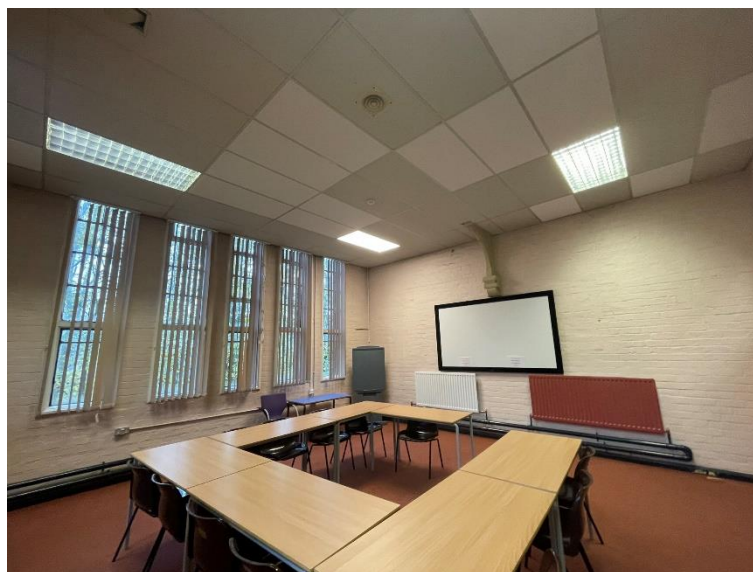
Photo 15 - Dated Light Fitting Example
