Project:

Purley Leisure Centre, Croydon**Asset Register**

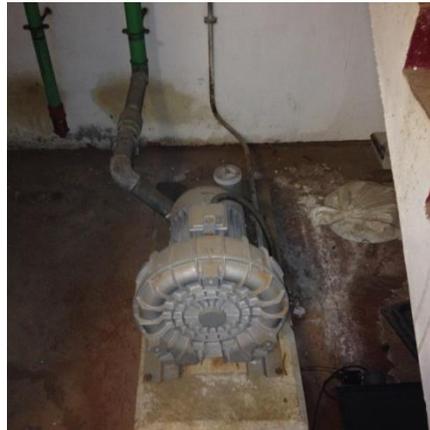
G.E.105

Aluminium air pump x 1

The air blower remains as per report back in 2015. Operation of air blower unknown as this was not in use during inspection.

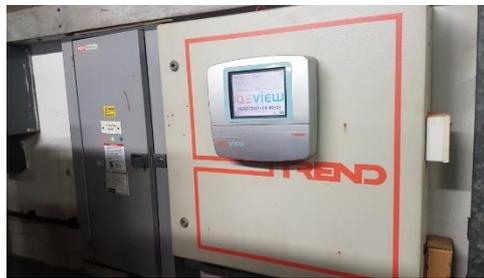
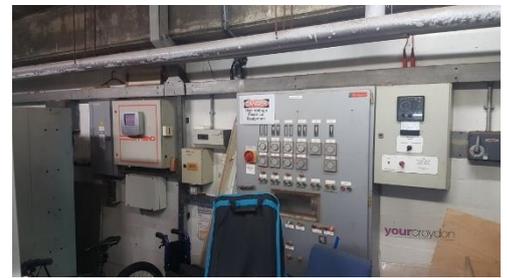
G.E.111

Trend BMS IQE View panel

The plant is in operation therefore we deem the control panel to be operating sufficiently. However we do not deem it to be operating in an energy efficient manner due to age and deterioration of sensors and control hardware.

We understand the Controls and wiring are in excess of 25 years old.

Replacements of the BMS would see benefit to user in terms of efficiency, operation, running cost reductions through improved services management.

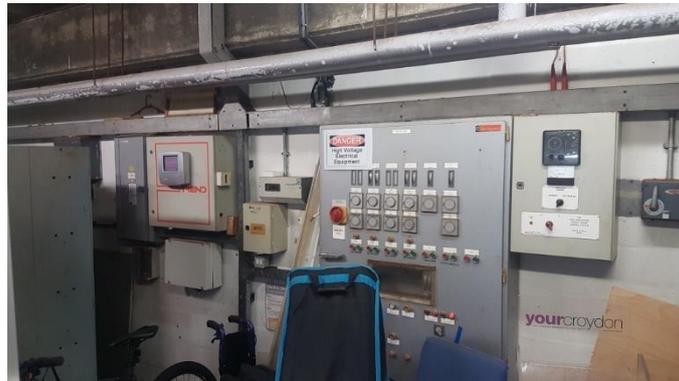
G.E.113

Nuaire fan 1 and 2 AHU control panel

The controls are beyond their economical life.

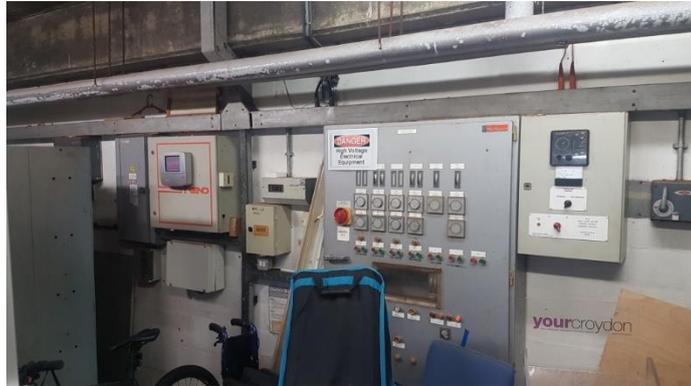
G.E.114

Eiohurst BMS lan M/Box control panel

The controls are beyond their economical life.

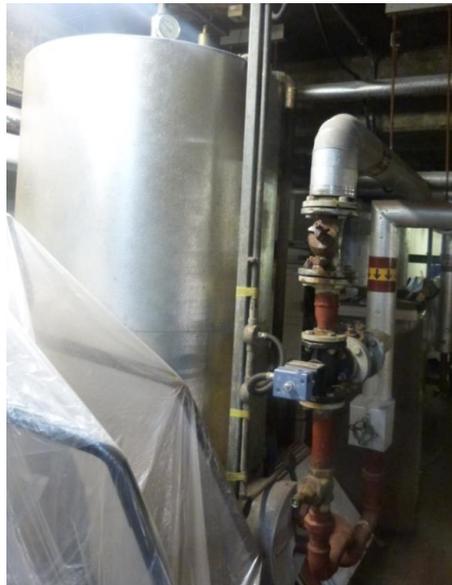
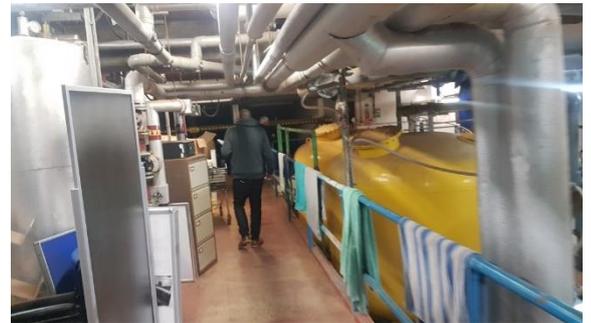
G.M.30

Calorifiers DHWS

Annual risk assessment is carried out by others on the domestic systems as part of the Legionella check. We have not seen latest report as of 2019. Last report by Aquatech Environmental Services Ltd 13.02.2013 due for renewal 2015. Temperature gauges faulty. Fair condition for its age.

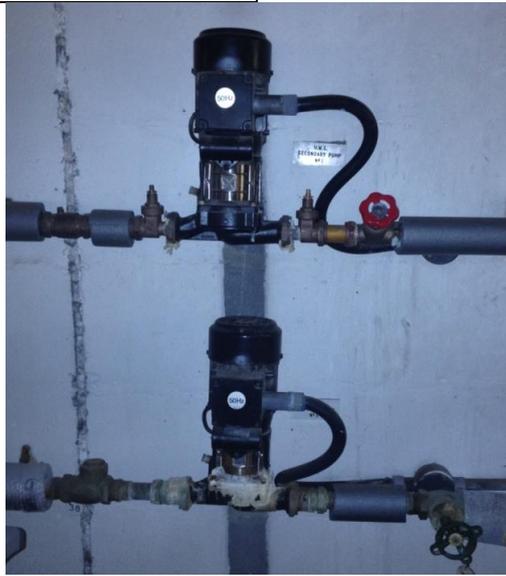
G.M.35

Circulating pumps DHS secondary pumps 1 & 2

Showing signs of corrosion from the pump seals and casing.

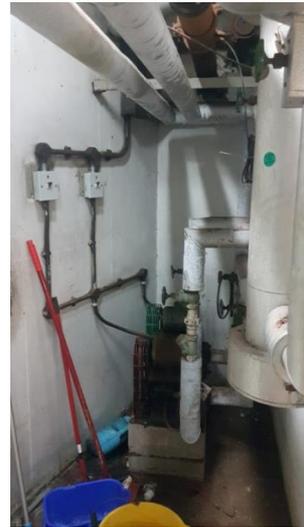
G.M.37

Heating secondary pumps

Pump showing major signs of corrosion to casing. Appears belt have been replaced recently. No speed control on the pump set. Spare parts for the plant/equipment may become obsolete.

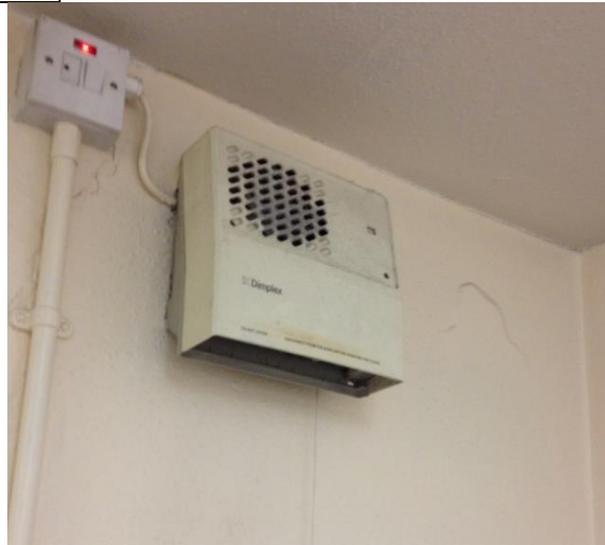
1.E.16

Convactor blow heater

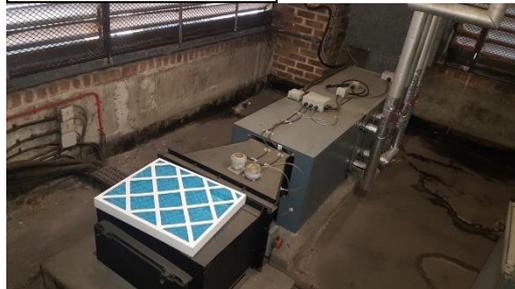
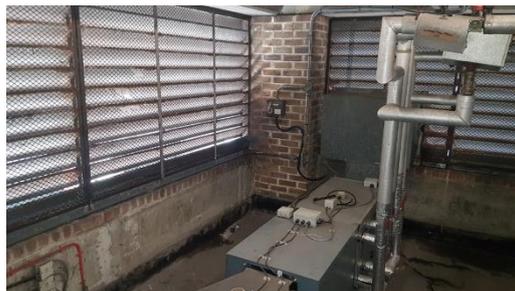
2.M.1

AHU 4 Teaching pool - supply & extract

AHU 4 and 5 have been replaced within the past 2 years. However the ductwork, pipework and controls associated remain as existing.

Replacement of the HVAC generally associated (pipework control valves, sensors, control panel, etc) with the new AHU would see significant improvements. None of the Ductwork in the Plantroom seems to be insulated. At least the Intake, Supply & Return Air Ducts require insulation.

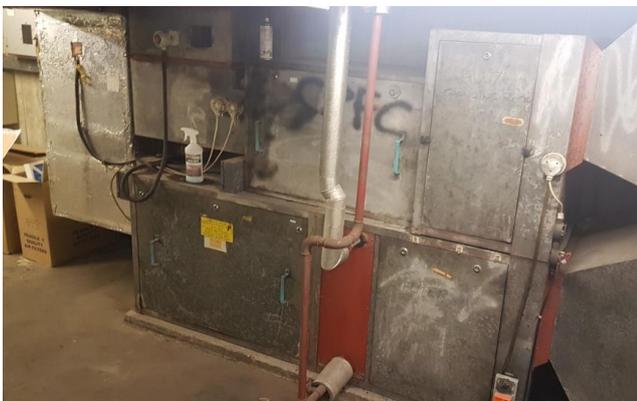
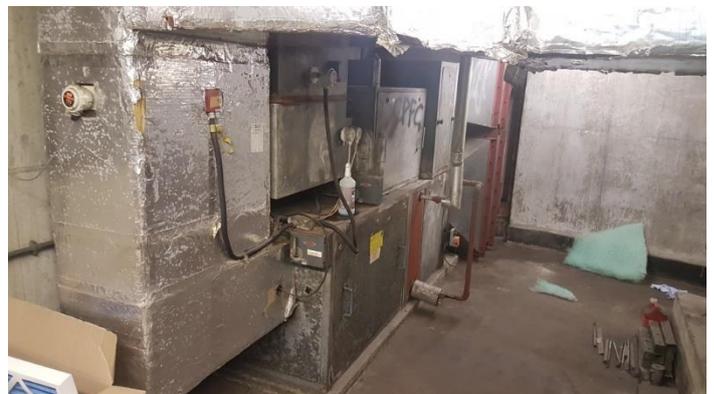
2.M.10

AHU7 Supply & extract unit

The Fan has been replaced within the past 2 years. However the AHU casing etc is still in poor condition along with associated HVAC.
Replacement of the HVAC generally associated (pipework control valves, sensors, control panel, etc) with the new AHU would see significant improvements.
Only a small amount of Ductwork in the Plantroom seems to be insulated. At least the Intake, Supply & Return Air Ducts require insulation.
Suggest deep cleaning of internal ductwork and grilles from which the unit is served to reduce resistance.
Unit requires full internal clean and service.
Spare parts for the plant/equipment may become obsolete.

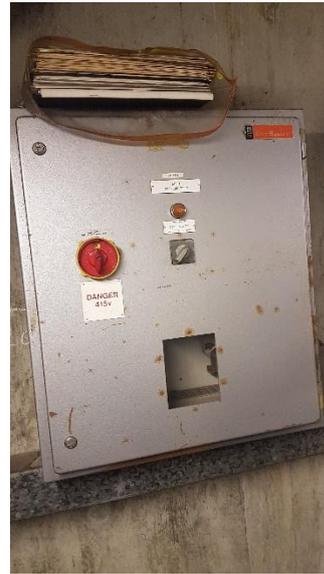
2.M.14

AHU7 changing room control panel

**The panel itself is at the end of economical life and appears to have had components removed. We would surmise that it is now used solely as an isolator for the AHU.
Spare parts for the plant/equipment may become obsolete.**

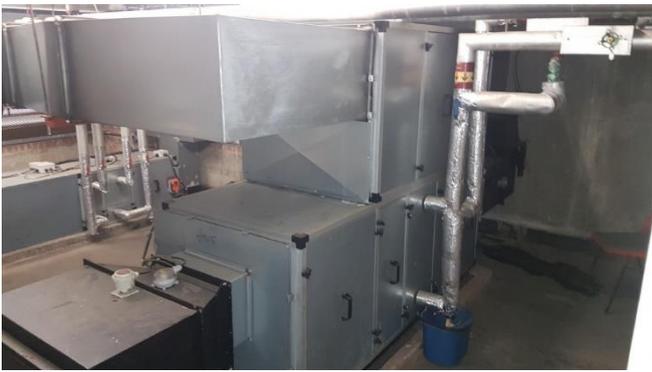
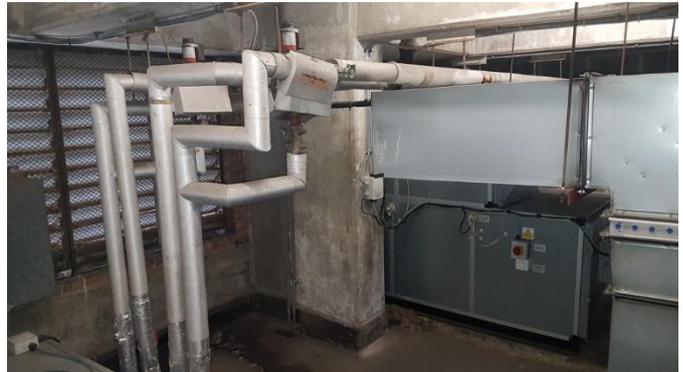
2.M.2

AHU 5 teaching pool void - supply

AHU 4 and 5 have been replaced within the past 2 years. However the ductwork, pipework and controls associated remain as existing.

Replacement of the HVAC generally associated (pipework control valves, sensors, control panel, etc) with the new AHU would see significant improvements. None of the Ductwork in the Plantroom seems to be insulated. At least the Intake, Supply & Return Air Ducts require insulation.

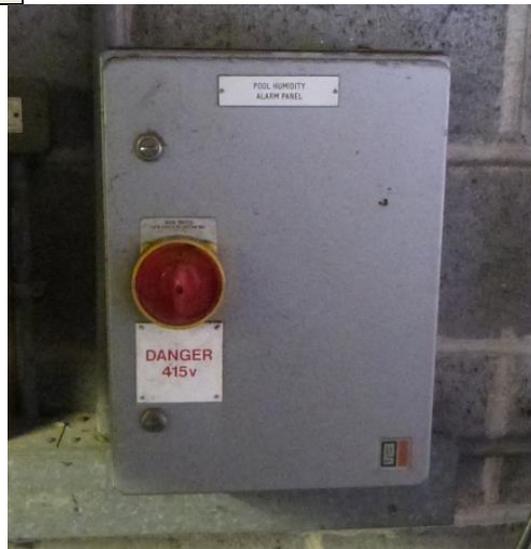
2.M.6

Pool humidity alarm panel

Condition of the panel is satisfactory and fair for its age.

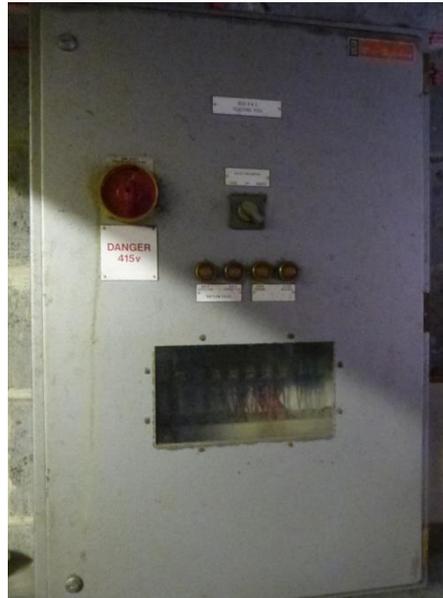
2.M.7

AHU 4 & 5 control panel

The panel currently allows the AHU to operate. We do not envisage that the controls provide energy efficient control. Spare parts for the plant/equipment may become obsolete.

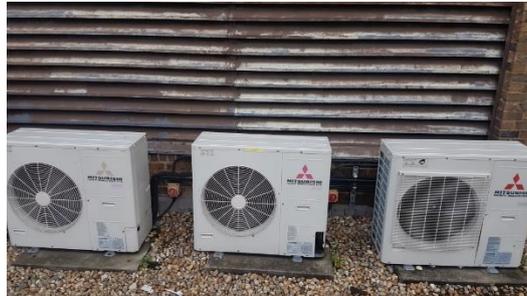
2.M.9

Mitsubishi air conditioner condenser outdoor units - max electrical load 15 amp

Unit 1 – installed in 2017 looks in good working condition.

Units 2 & 3 – installed in 2013. The appearance of the external condensers is fair for its age. We would suggest units are serviced to ensure condensers are operating as efficiently as possible (services to include re-gassing units).

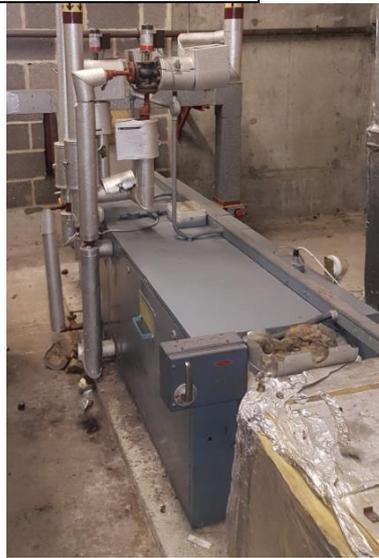
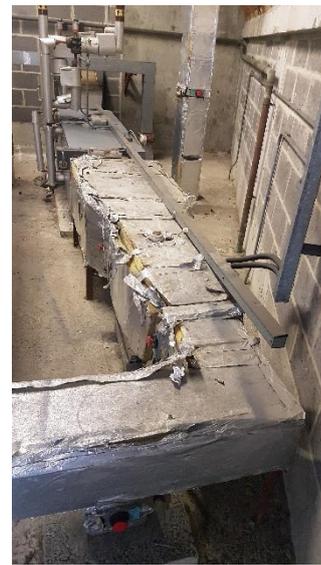
3.M.2

AHU6 disabled toilets & changing rooms supply belt drive

The Fan has been replaced within the past 2 years. However the AHU casing etc is still in poor condition along with associated HVAC. Replacement of the HVAC generally associated (pipework control valves, sensors, control panel, etc) with the new AHU would see significant improvements. Majority of the Ductwork insulation is currently falling apart, with a considerable length of ductwork without any insulation. At least the Intake, Supply & Return Air Ducts require insulation. Unit requires full internal clean and service. Spare parts for the plant/equipment may become obsolete.

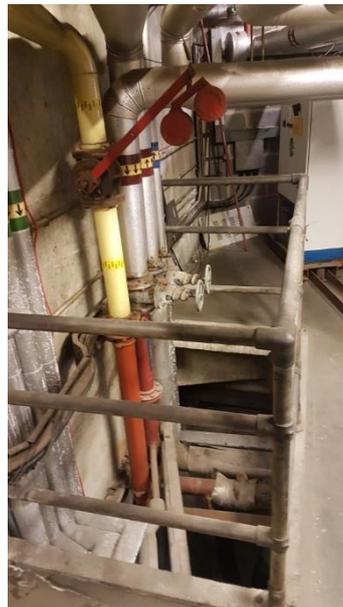
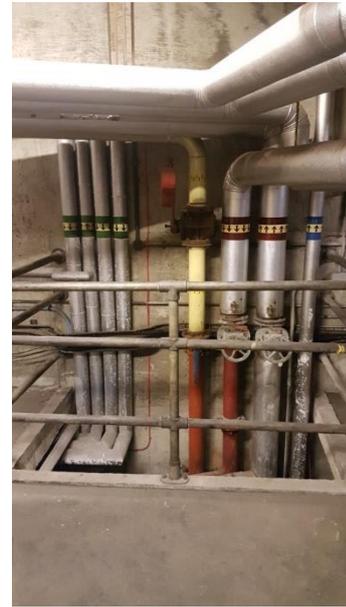
**No change - The operation of the valve should be checked along with annual gas servicing.
Should boilers be replaced we would suggest solenoid valve is installed in lieu of drop weight valve arrangement.**

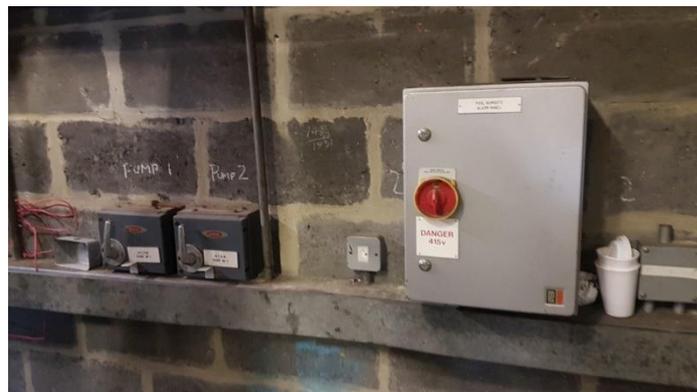
Pool humidity alarm panel

No change - The humidity alarm operation is unknown.

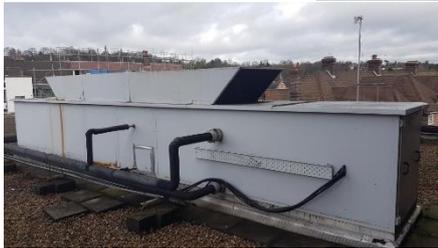
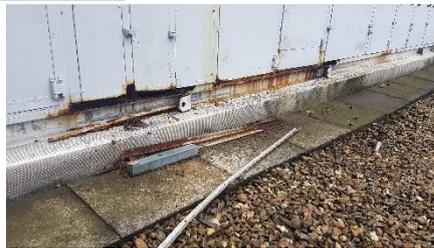
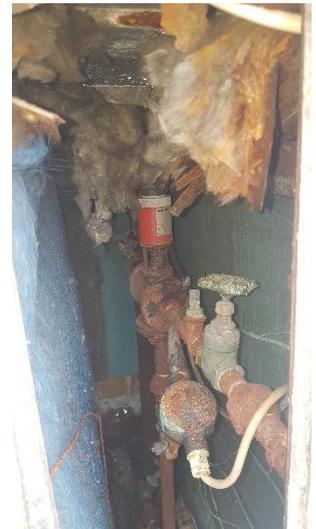
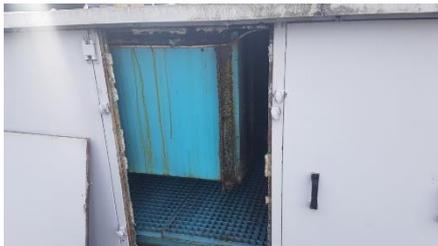
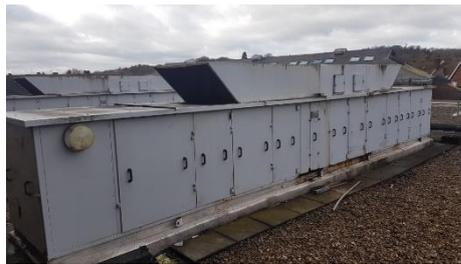
Pool Unit No 1 is not operational. Failure of other units would mean closure of the Pool as a suitable condition within could not be met. Compared with units installed at new Pools the operation is extremely inefficient. The units show signs of extreme corrosion which in some instances have been repaired. Spare parts for the plant/equipment may become obsolete.

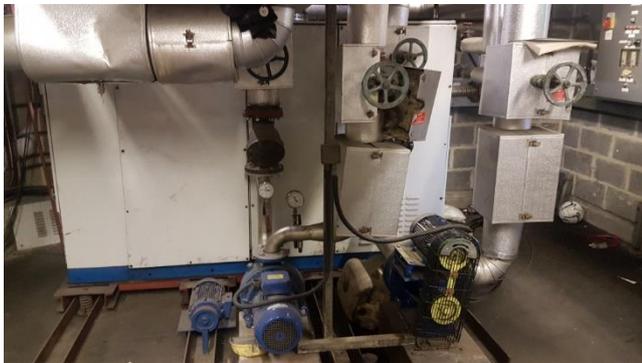
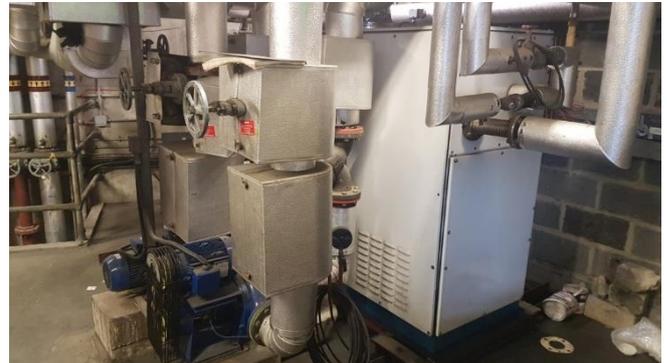
The pump is in good condition.

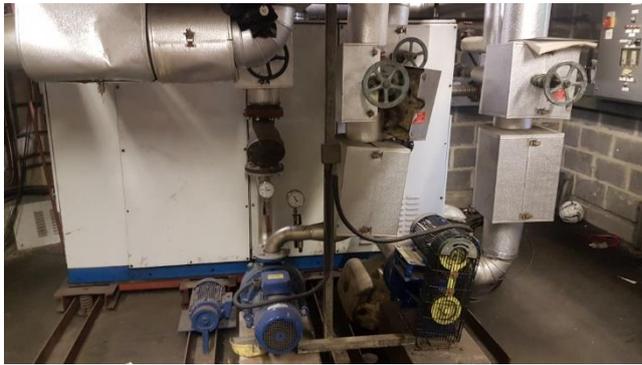
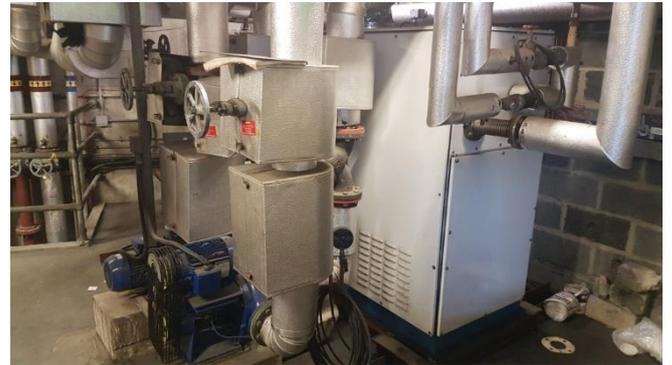
Belts and pulleys appear in good condition. The pump is belt driven and we deem belts are changed regularly as and when they fail or show signs of wear.

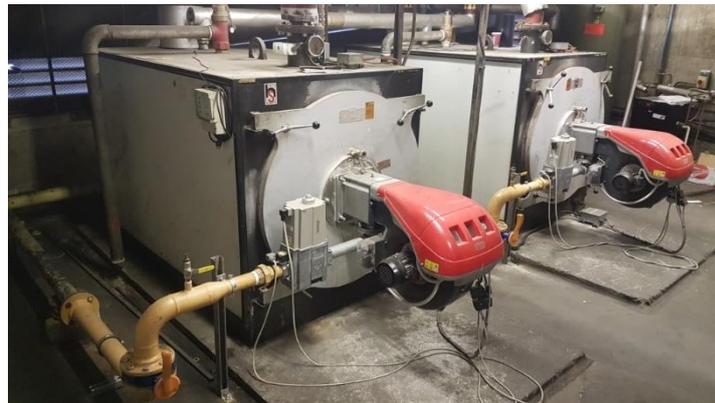
The boilers are original and in fair condition.

The Burners on the 2 No. Boilers have been replaced with new Riello burners within the last 2 years.

Pipework insulation is falling apart in some locations and needs to be replaced.

Replacement of the boilers, control valves & sensors would provide improved efficiency in terms of running costs and energy use.

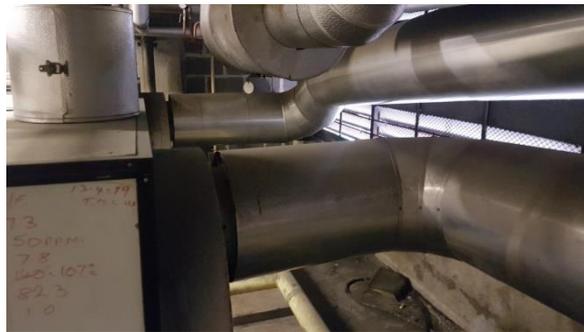
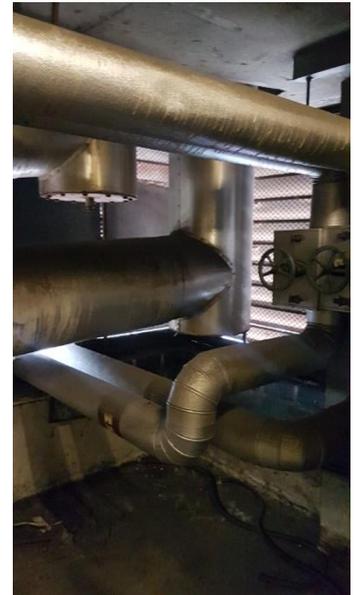
The flues are showing signs of corrosion and should be checked annually as part of the gas aafe checks undertaken.

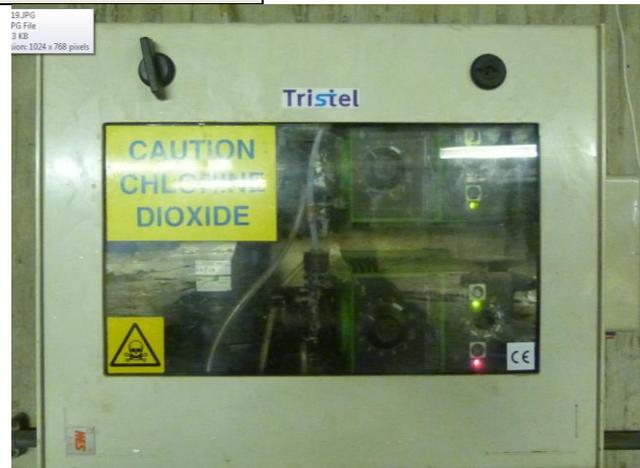
The pumps appear in fair condition for their age and appear to be operating with no alarm indication.
